PROGRESS REPORT

Kunde Hospital Rebuild (Main Block – no. 2)

Prepared and Submitted By:
Yangji Doma Sherpa
Project Coordinator (Nepal)
The Sir Edmund Hillary Foundation – Canada

Date: 20 June 2016

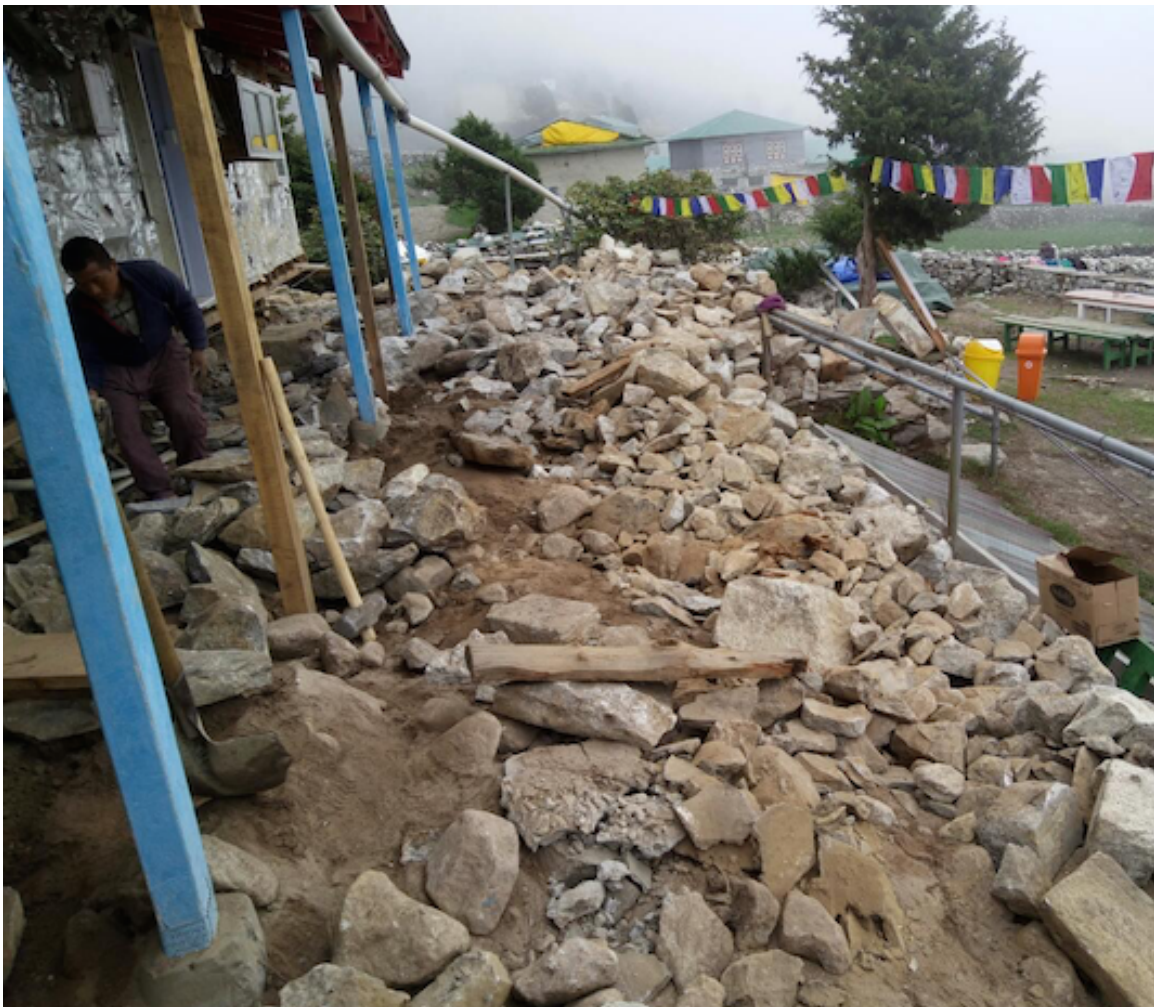
Figure 2: The outer rock wall structure of the building was scraped and demolished keeping the internal wooden structure intact.

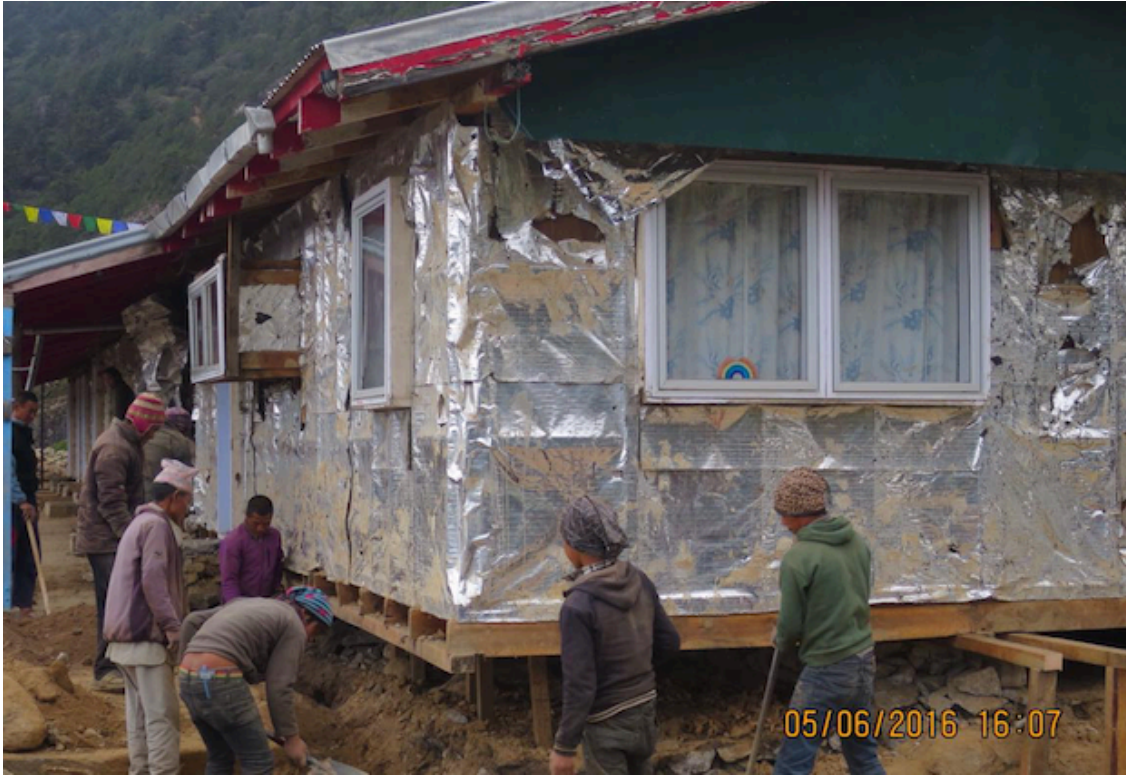
Figure 3: The main hospital block after demolishing the external rock wall. Demolishing and site clearance work has been completed within few days. The outer silver cover is the insulation material, which has been kept intact.

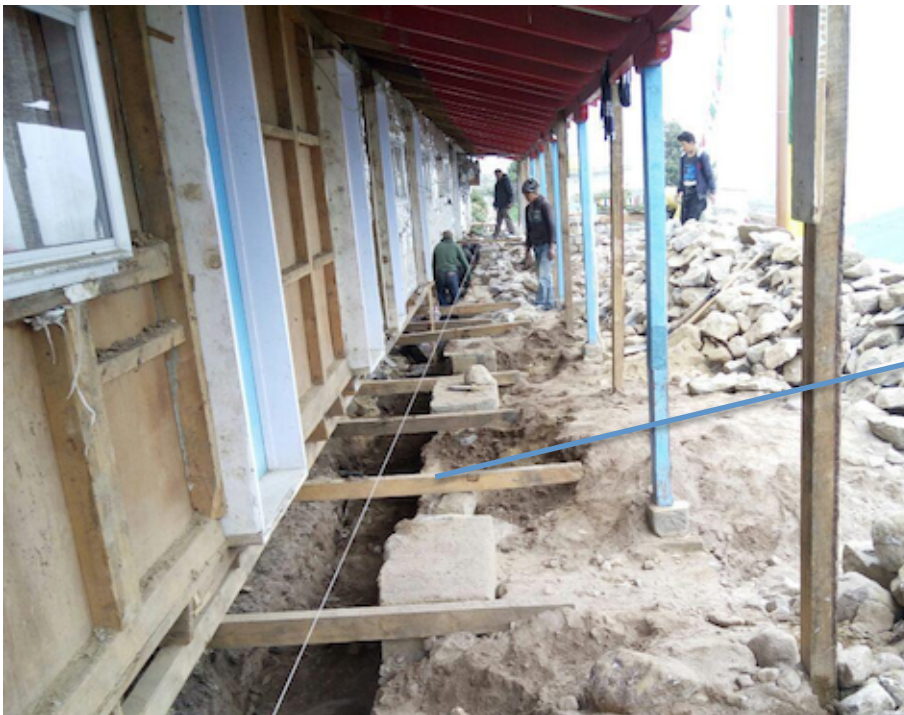
Figure 4: Wooden support system was setup for supporting the internal structure at the bottom, side, back and front (in picture) of the building during the construction.

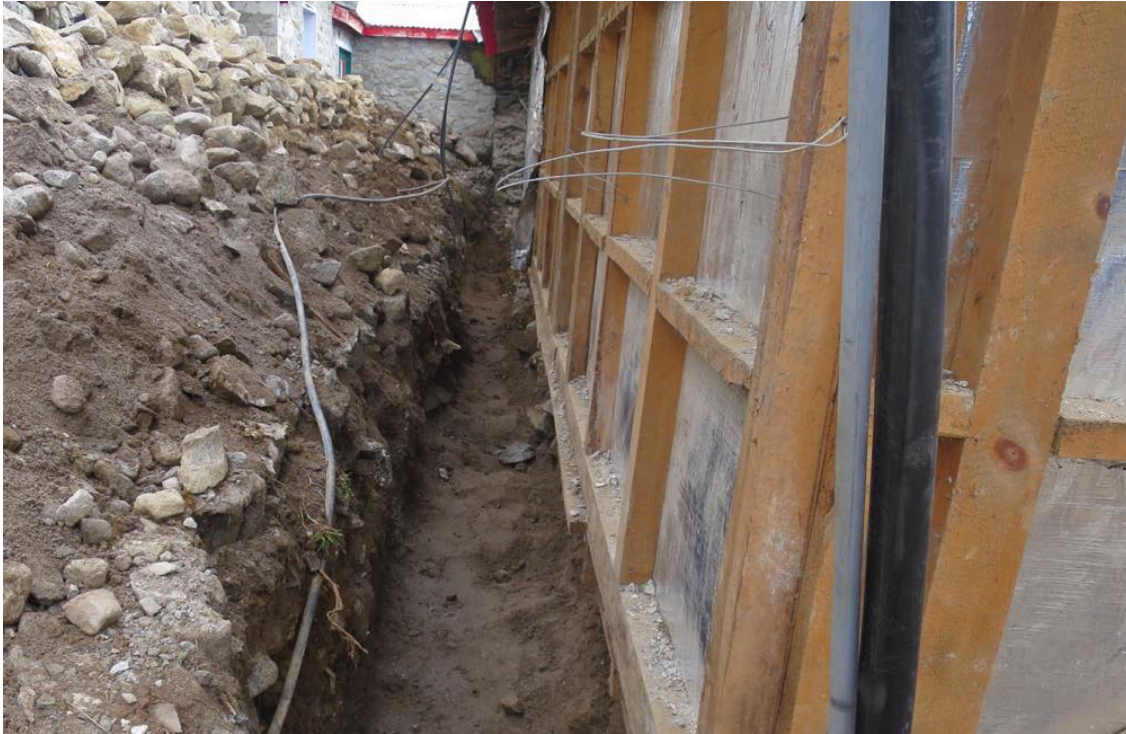
Figure 5: Surprisingly, there was no foundation in the older structure. The rock wall of the building has been constructed above ground level. Thus, a new 3 feet depth and 2.5 feet width foundation was dug as per the instructions provided in the engineering design

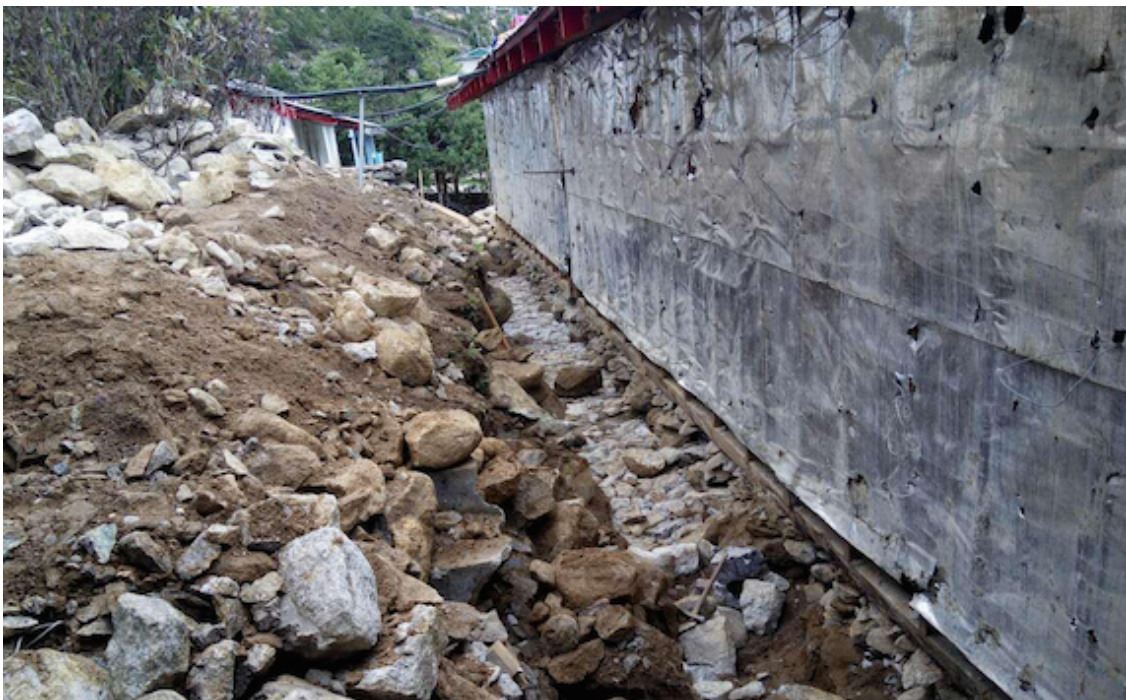
Figure 6: Stones and cement has been used in the new foundation. Cement was not mentioned in the engineering design, but has been used to make it firmer as suggested by the engineers recently. Since there was no foundation in the previous structure, most of the stones were used in foundation. Luckily, we got 6 strong stonebreakers to break more stones, thus everything has been running smoothly.

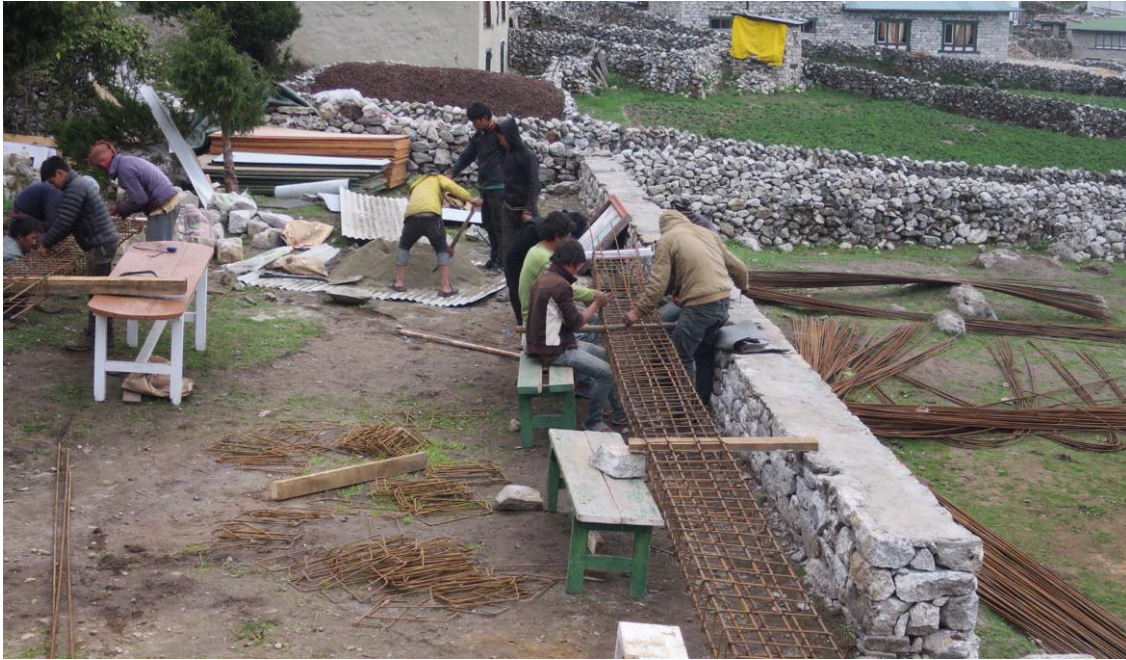
Figure 7: Workers weaving a D.P.C. tie beam with varied diameter iron rods following the instructions provided in the engineering design.

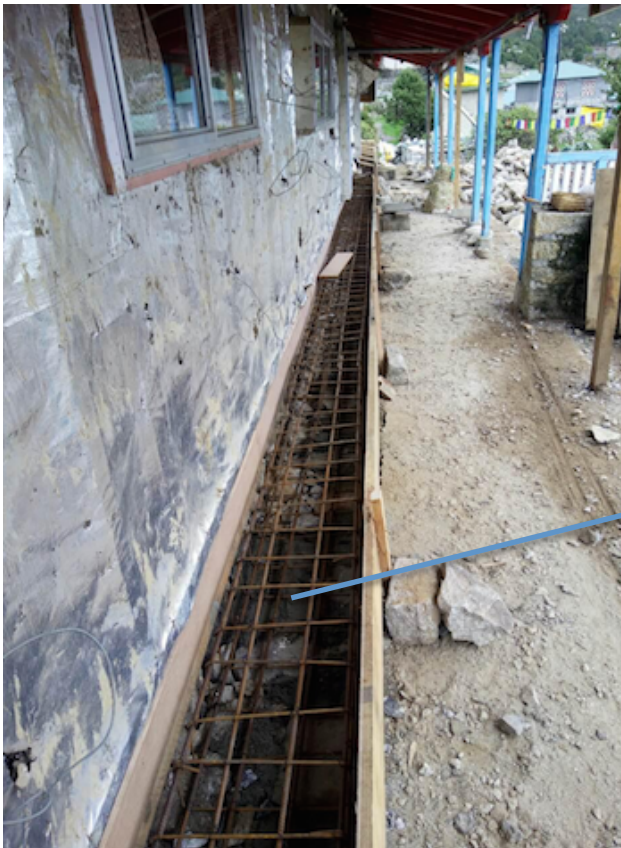
D.P.C. tie beam made out of iron rod

Figure 8: D.P.C. tie beam placed horizontally all round the building above the ground level. The D.P.C is 9-inches in height and 18-inches in breadth.

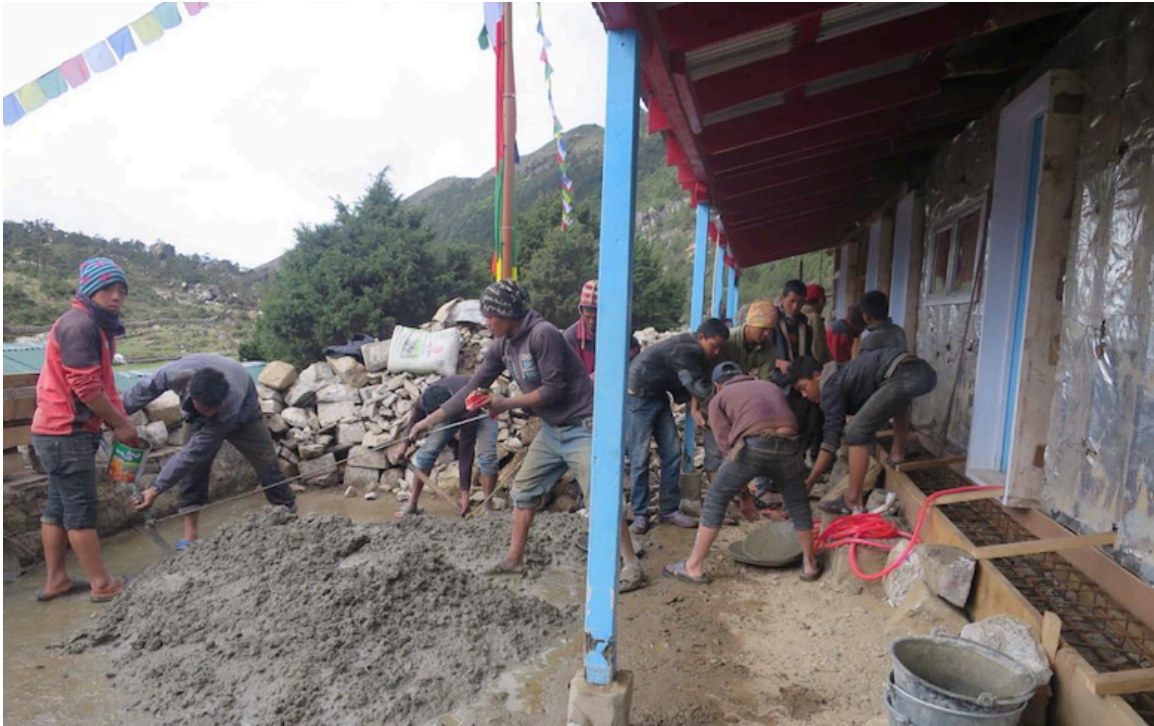
Figure 9: Workers making cement mortar combining a mixture of sand and cement for D.P.C.

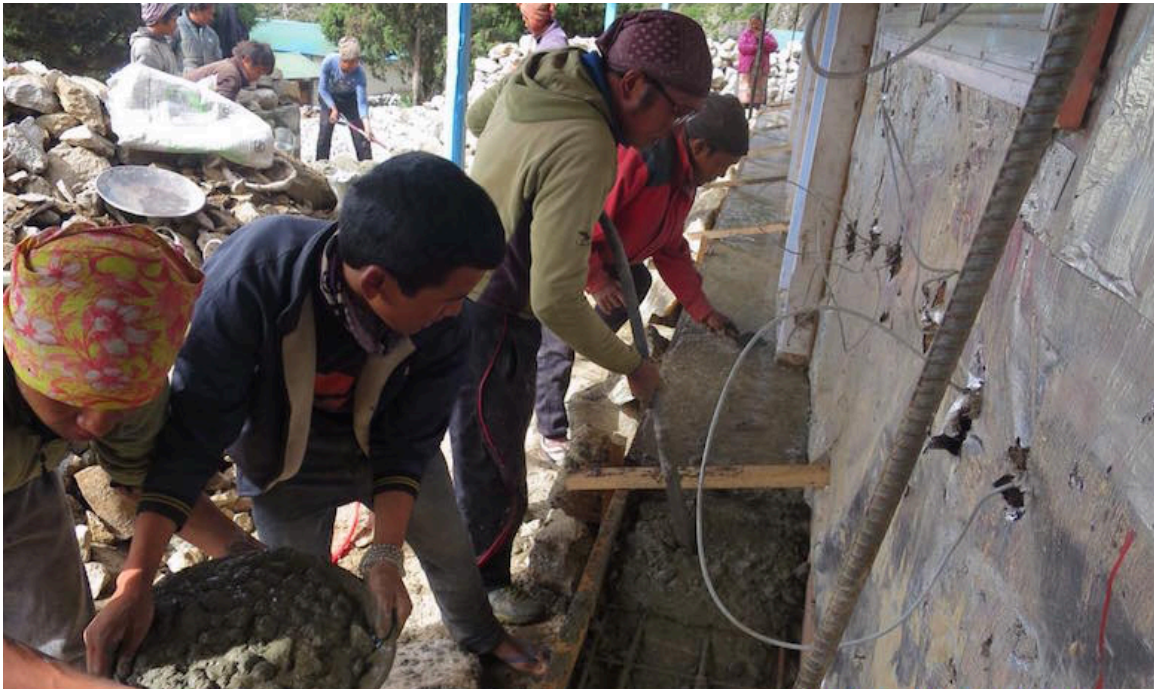
Figure 10: Spreading and compacting cement mortar in the D.P.C. layer with a machine.

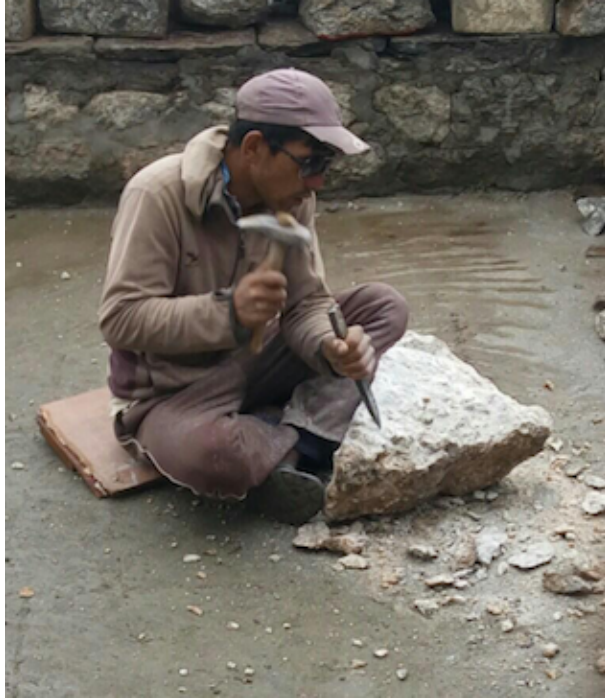
Figure 11: Worker shaping stone into appropriate shapes required for construction

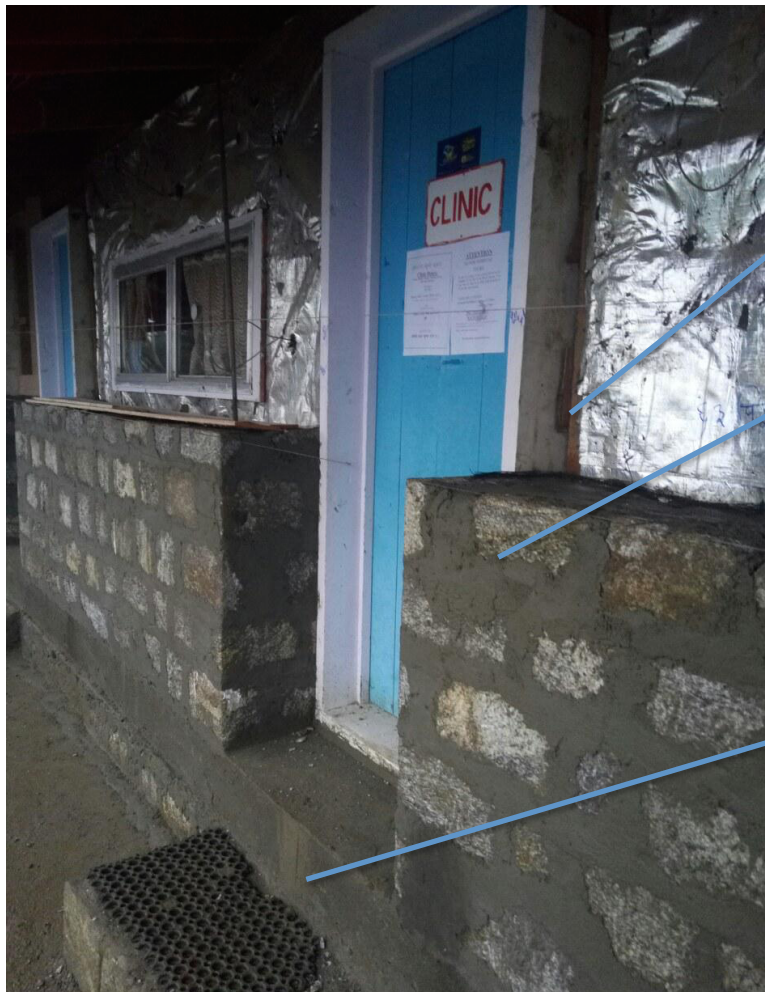
A sill tie will be placed somewhere at this level

Stone masonry wall with cement mortar

D.P.C layer (made out of iron rod and cement mortar)

Figure 12: Building stone masonry wall with cement mortar as suggested in the design. It is currently ongoing and reached just below the sill tie level.
